Reference: NHTSA Identification Number 00V-135

Dealer Service Instructions for:

1994-1996 (BR) Dodge Ram Trucks

SAFETY RECALL TO INSTALL A BLOWER MOTOR RELAY AND INSPECT YOUR TRUCK'S IGNITION SWITCH AND REPLACE IT IF NECESSARY

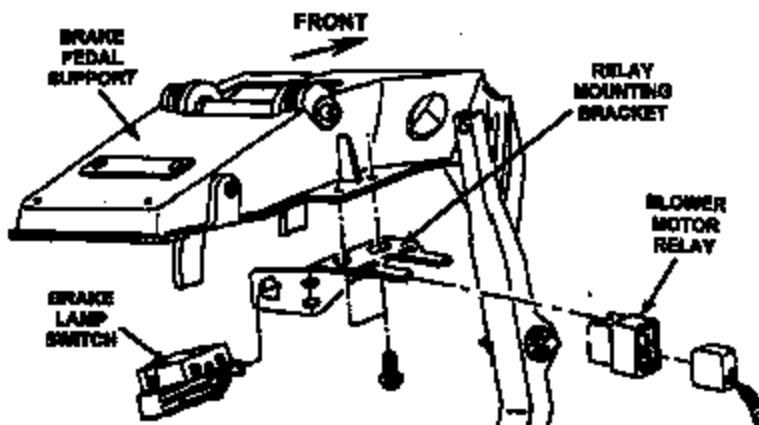
Figure 1

1. Inspect the brake pedal support bracket for the presence of a blower motor relay attached to the brake lamp switch bracket (Figure 1) or locate a blower motor relay that is secured near the brake pedal bracket with a tie strap.

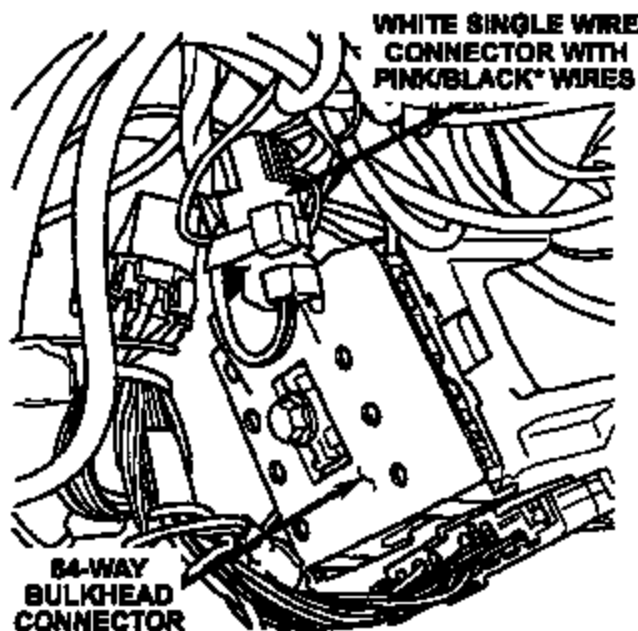
Figure 2

2. If a blower motor relay is NOT found, inspect the area near the 84-way bulkhead connector for a WHITE single wire connector with BLACK ends that connects two PINK with BLACK tracer wires (Figure 2). If the connector and wires are present, follow the wiring harness to locate the blower motor relay that is secured under the instrument panel.

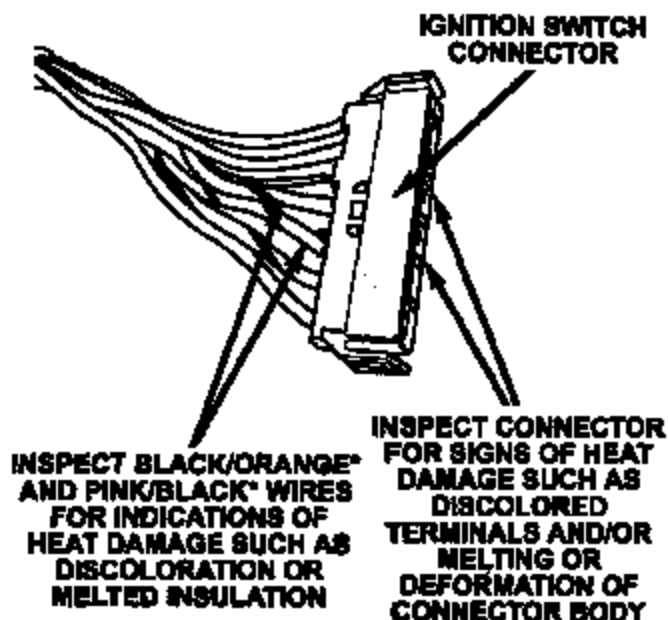
Figure 5

6. Disconnect the 7-way ignition switch electrical connector (Figure 5).
7. Inspect the 7-way ignition switch connector for heat damage near the 4th and 5th terminals (BLACK with ORANGE tracer and PINK with BLACK tracer wires) (Figure 5).

- Look for brown or black discoloration of the wire insulation or melting of the wire insulation near the connector.
 - Check the wiring terminals for discoloration.

- Inspect the connector for indications of melting or deformation.
8. Inspect the ignition switch assembly for heat damage near the 4th and 5th terminals (Figure 6).

- If the 7-way switch wiring connector has indications of heat damage, the ignition switch wiring harness pigtail must be replaced. Continue with Section “C – Replace Ignition Switch Wiring Pigtail.”

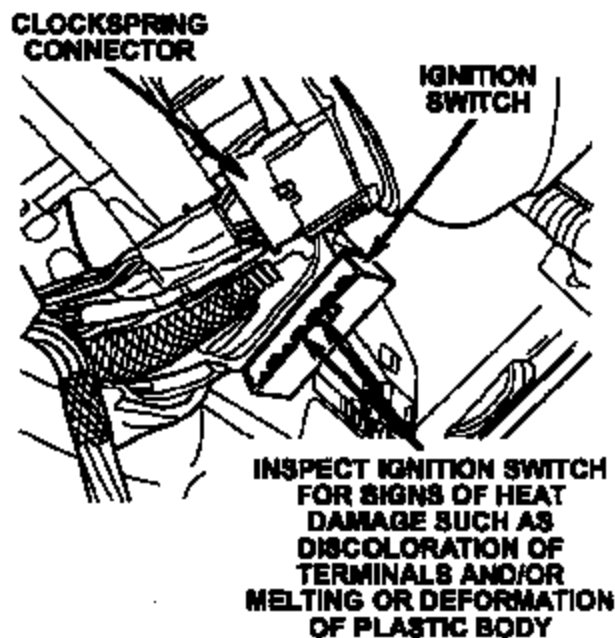
Figure 6

- Check the ignition switch terminals for discoloration.
 - Inspect the ignition switch connector and body for indications of melting or deformation.
9. ➤ If the wiring connector and switch assembly are NOT damaged, continue with Section “E – Install Blower Motor Relay and Overlay Harness.”

- If the ignition switch assembly has indications of heat damage, the ignition switch assembly and the wiring harness pigtail must be replaced. Continue with Section “C – Replace Ignition Switch Wiring Pigtail.”
